Fires and explosions in the fuel tanks

This part of report presents the analysis of the causes and lessons learned from the August 22nd 2009 accident occurred on production and control station "KONDA" near Yugra, Khanty-Mansiysky region, Russia/

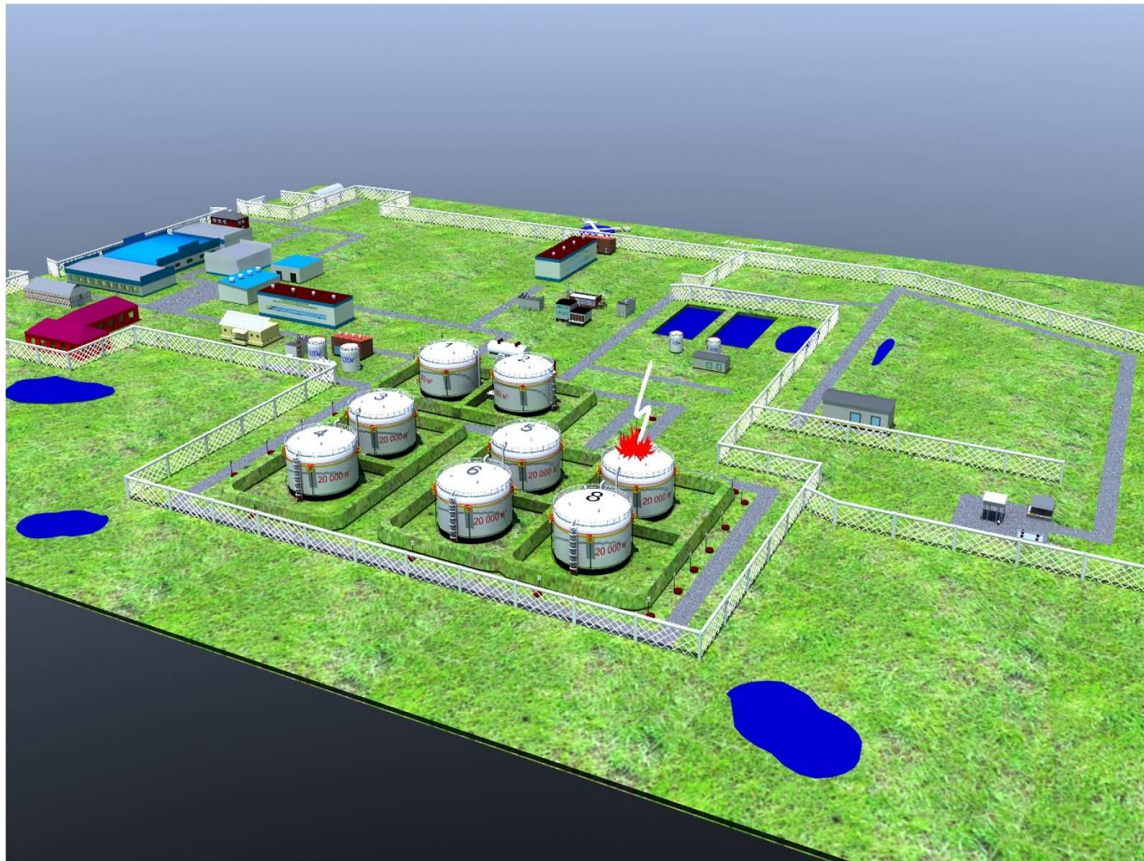
On 22th of
August in 2009
at 17.06

- during thunderstorm the lightning resulted in explosion in tank N^o7
- Valves N^o 1, 2 at the tank N^o7 were closed automatically

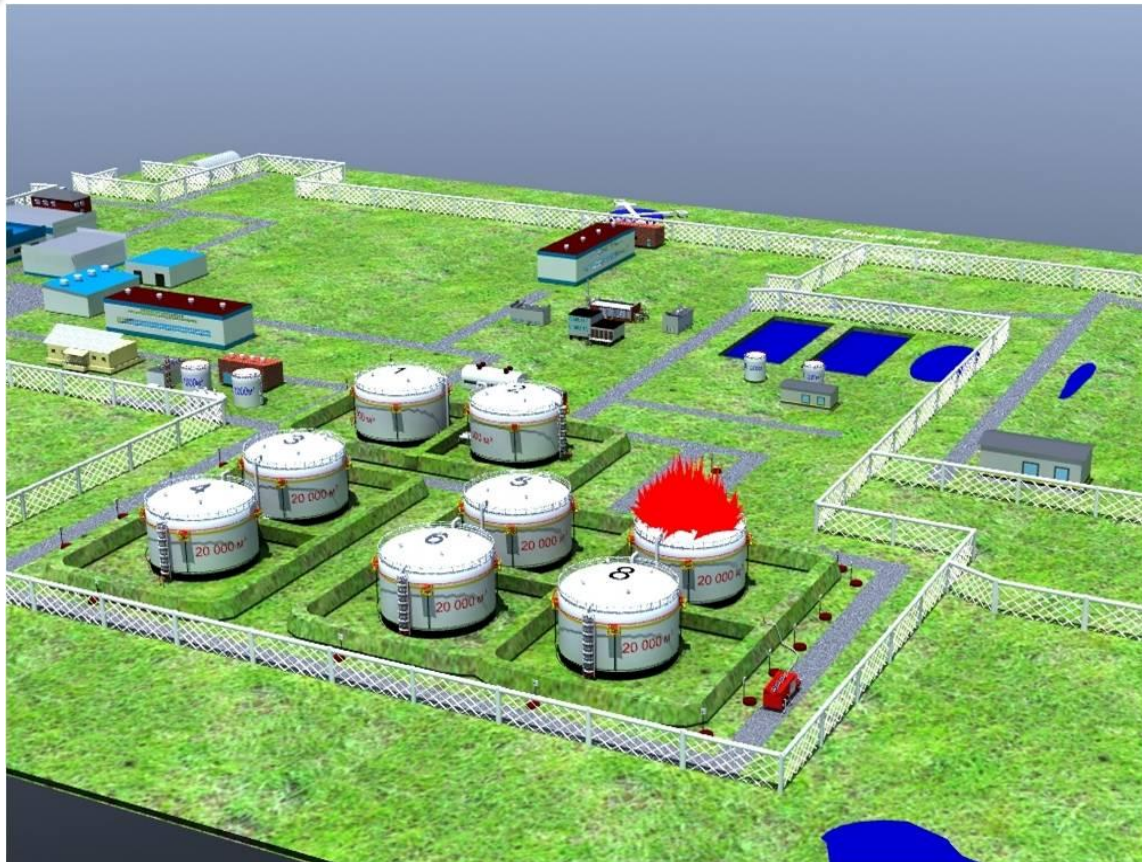
17:10

- Sound and light alarm system of the tank №7 and foam system were activated. Tank of crude oil was burning by free flame all over the whole area

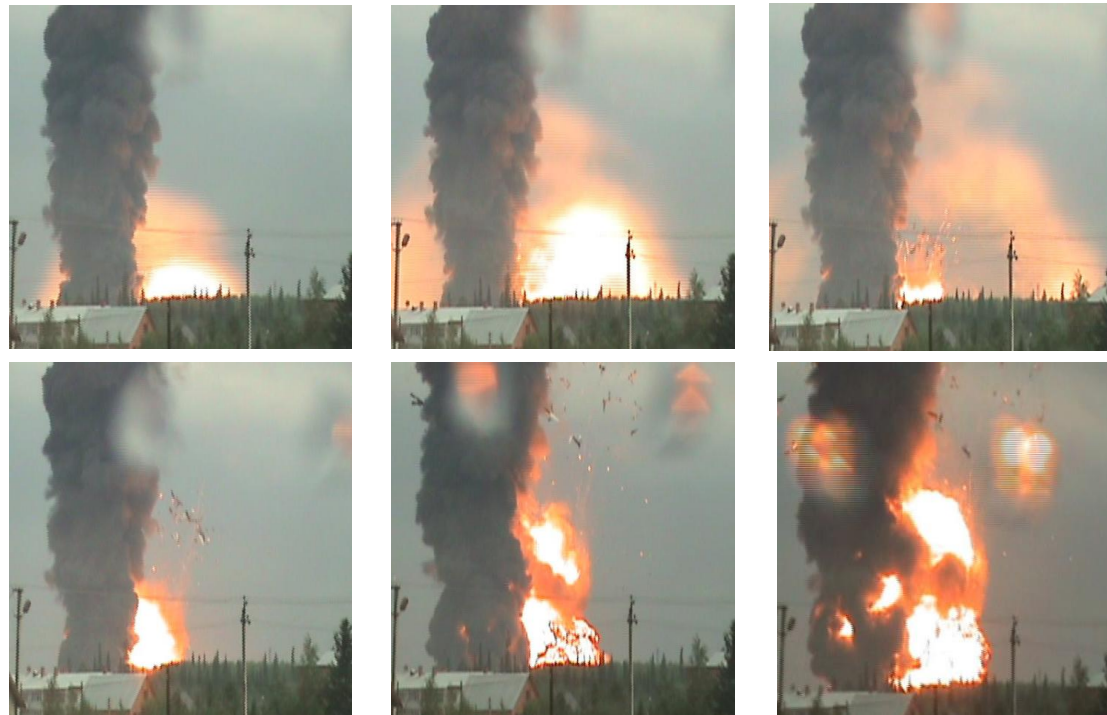
17.35

- The explosion in tank N^o8 occurred, as a result the tank was fully destroyed. The metal parts of the tank scattered on the Park territory and outside it at a distance up to 300 meters

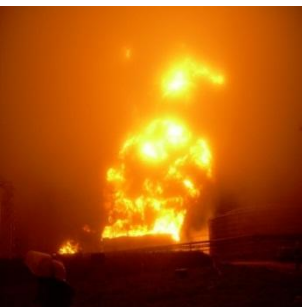
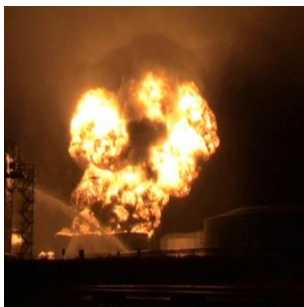
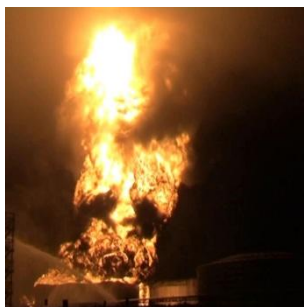
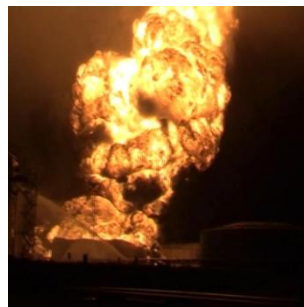
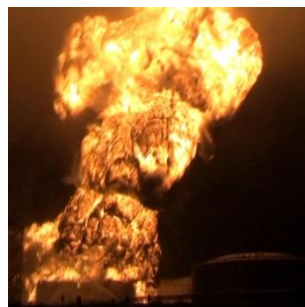
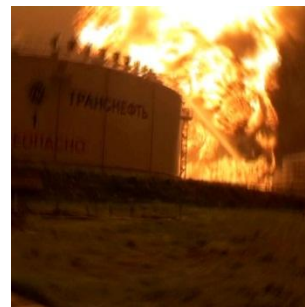
**About
04.00**

- blowout from the tank N^o5 occurred (Rys. 6, 7). It resulted in fire spreading on the tank N^o4

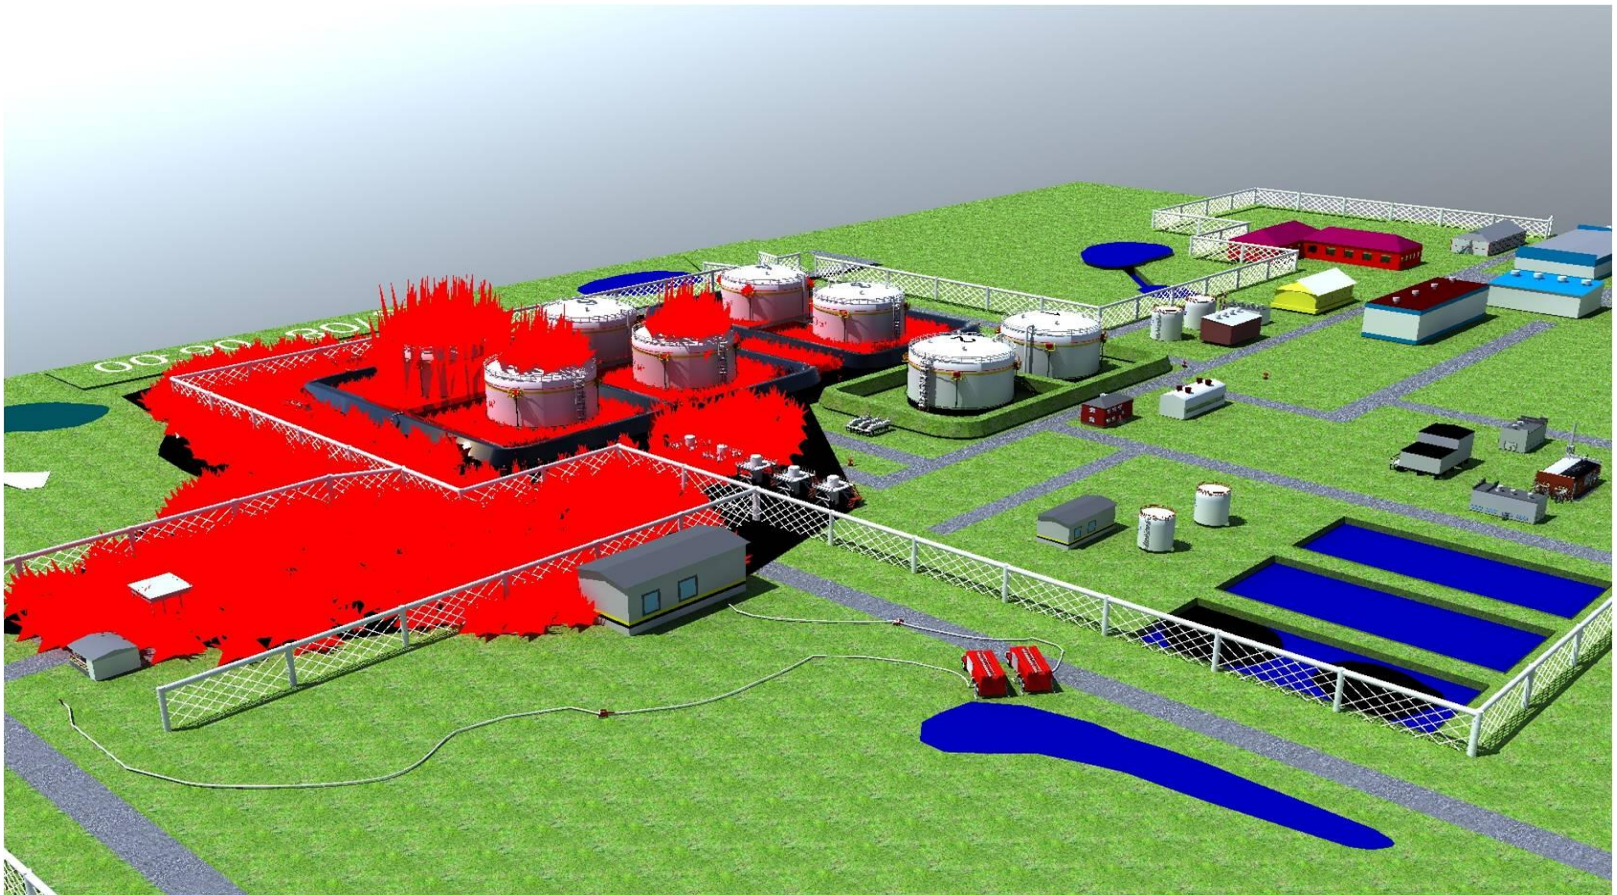
The situation on 23.08 time 06.00

- Three foam attack using sublayer method of extinguishing fires in the tank №4 were organized in the period of time from 20.00 on 23rd August, 2009 to 04.00 on 24th August, 2009. This made it possible to practically stop the burning and to prevent an explosion in the tank №4.

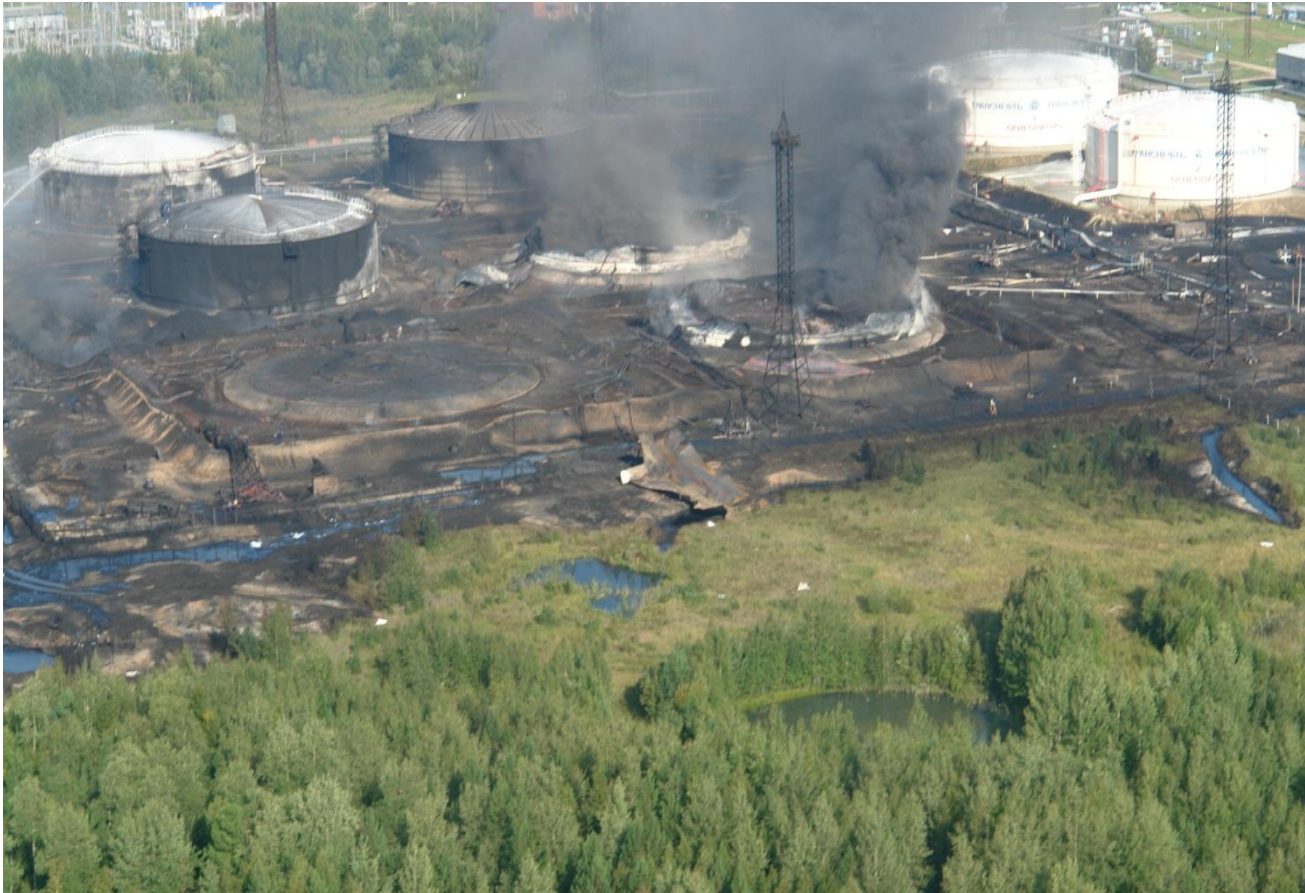
THE ACCIDENT

- As a result of a fire the tanks N^o 5,7,8 were completely destroyed. Tanks 3, 4, 6 were partially damaged. There is damage to the equipment of tanks N^o 1, 2

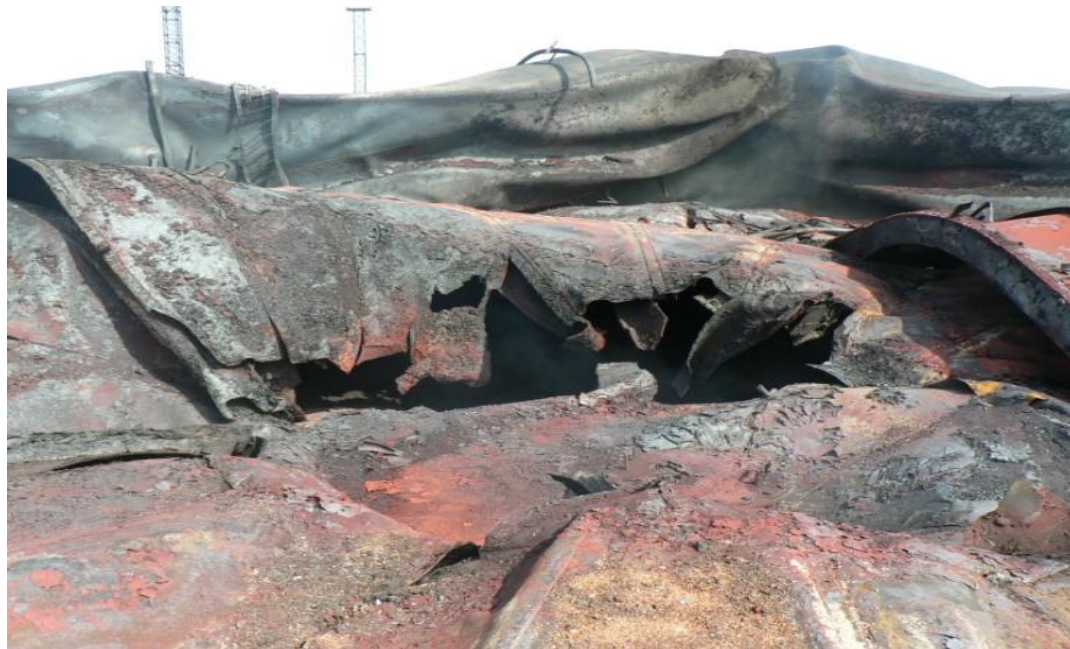
The cause of the fire in the tank №7 was a direct hit on the roof of the tank of lightning. During the first hit lightning protection system protected the object. But it caused a high level of electric field intensity over the territory of the object and the metal elements of all structures, including tanks. Re-lightning discharge was directed in the tank and resulted in the explosion of gas-air mixture in the tank. This led to the partial destruction of the roof and the ignition of vapors of oil. The roof was dropped from the tank
