Fires and explosions in the fuel tanks

This part of report presents the analysis of the causes and lessons learned from the August 22nd 2009 accident occurred on production and control station "KONDA" near Yugra, Khanty-Mansiysky region, Russia/

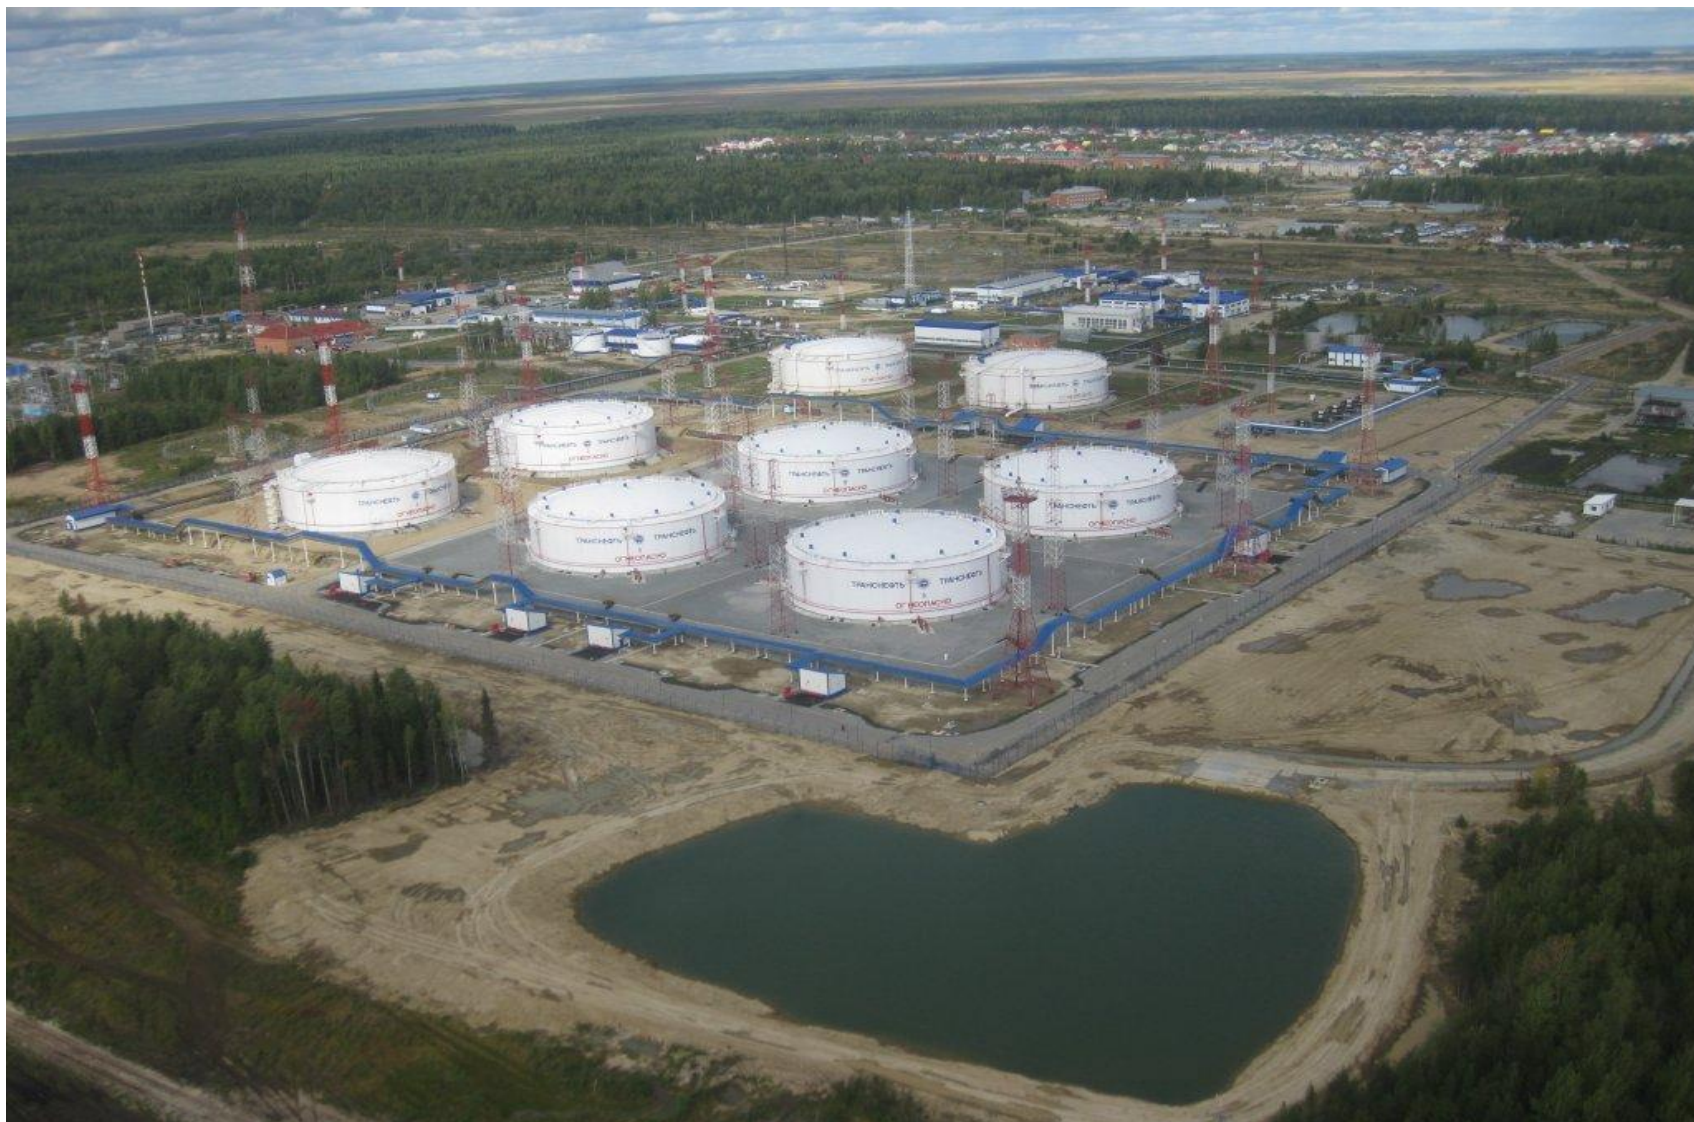
Reservoir park «KONDA»

- **As a result** of explosion four firefighters were killed and four firefighters were injured
- **As a result** of a fire three tanks were completely destroyed and three tanks were partially damaged. There were damage also the equipment of two tanks.

- As a result of a fire the tanks N^o 5,7,8 were completely destroyed. Tanks 3, 4, 6 were partially damaged. There is damage to the equipment of tanks N^o 1, 2
